ENGINEERING DEPARTMENT
TR-RE-CCSD-F0-1117-3
May 9, 1968

GLOBE VALVE, 3/4-INCH, 6000 PSIG

Pacific Valve Co. Part Number 3/4-S-17250Y-12K-GL(XXS)

NASA Drawing Number 75M09618 PGLV-3

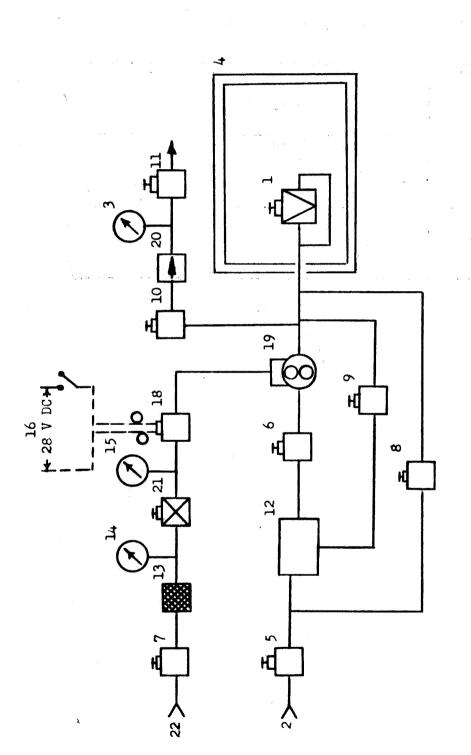
Figure 3-1. Proof Pressure and Burst Test Schematic

3.1.3	The specimen shall be inspected for leakage and distortion.
3.2	TEST PROCEDURE
3.2.1	The test specimen was installed in the test setup as shown in figures 3-1 and 3-2 utilizing the equipment listed in table 3-1.

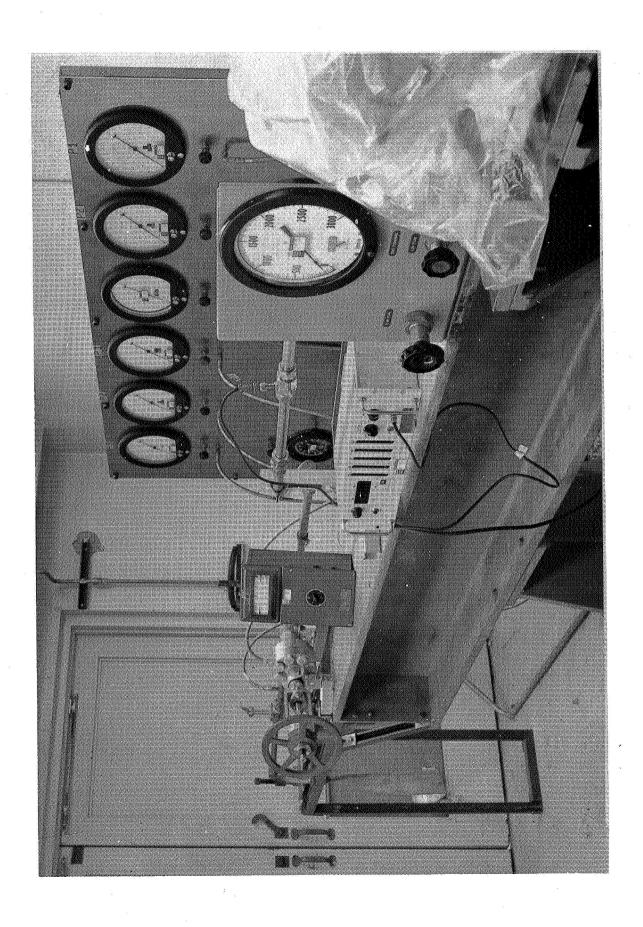
Figure 5-2. Flow Test Schematic

5.2	TEST PROCEDURE
5.2.1	The test specimen was installed in the test setup as shown in figures 5-2 and 5-3 using the equipment listed in table 5-1. Each hand valve and regulator 5 was closed.

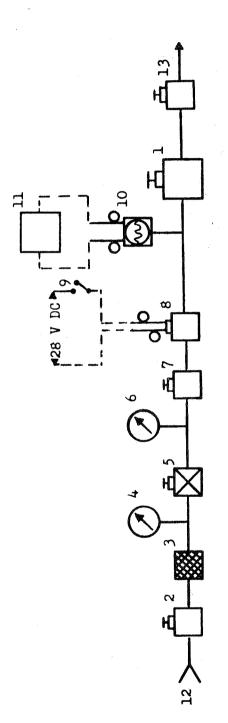
Figure 7-2. Surge Test Schematic

Note: All lines 1/2-inch except for gage lines which are 1/4-inch. Refer to table 7-1 for item identification.

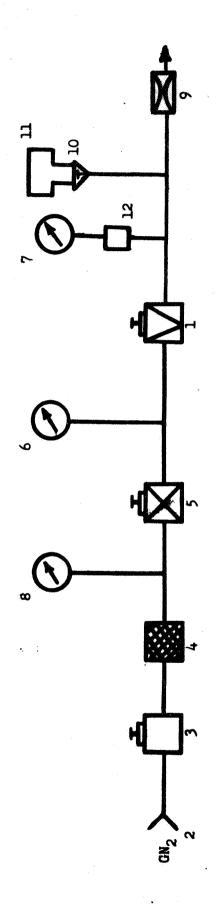
Figure 12-1. Seat Erosion Test Schematic

Note: Refer to table 12-1 for item identification.

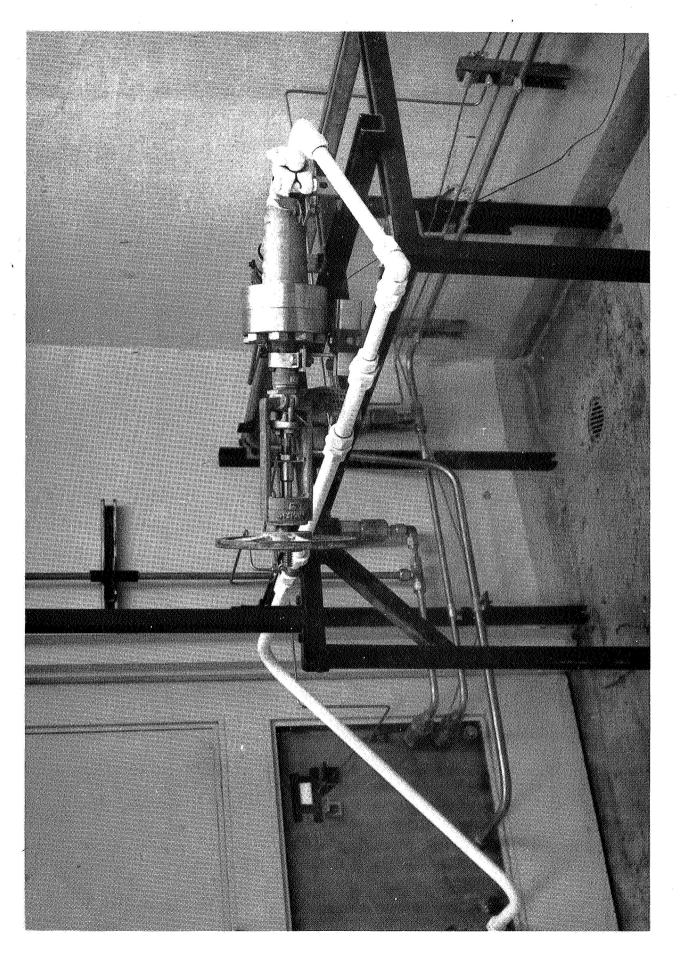
12.2	TEST PROCEDURE
12.2.1	A functional test was performed according to section IV due to 72 hours lapse time since the last functional test.
12.2.2	The test setup was then assembled as shown in figure 12-1 and 12-2 using the equipment listed in table 12-1.

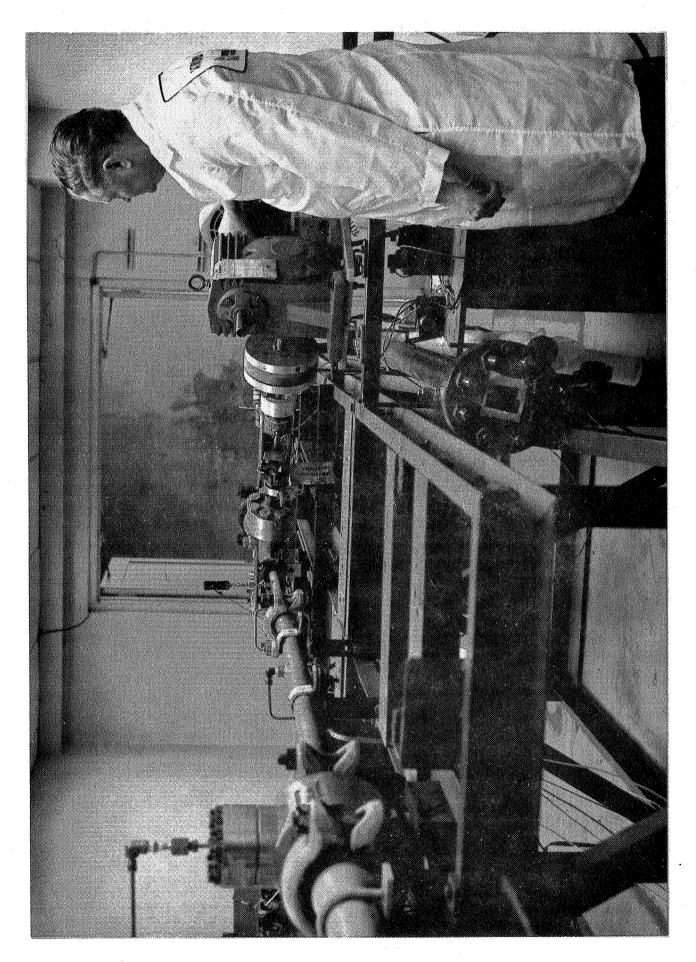
Figure 13-1. Cycle Test Schematic

13.2	TEST PROCEDURE
13.2.1	The test setup was assembled as shown in figures 13-1 and 13-2 using the equipment listed in table 13-2.
13.2.2	All valves were closed and the pressure regulators were adjusted for zero outlet pressure.

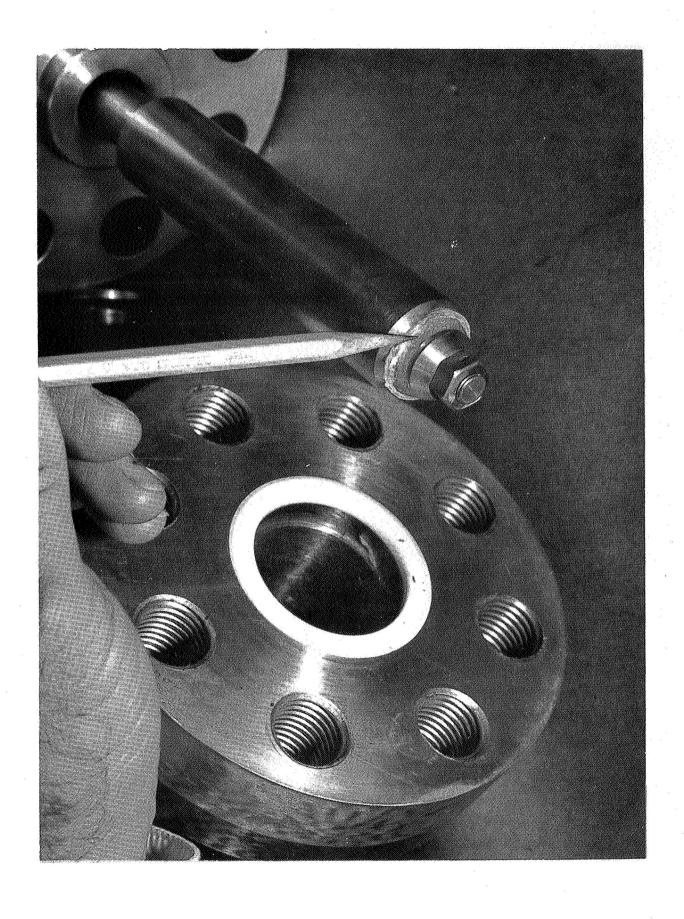
Figure 13-3. Seat Failure After 562 Cycles

The specimen was successfully cycled until cycle 562, at which time excess leakage through the seat became apparent. The specimen was disassembled and it was noted that the seat was badly eroded. Cycle testing was discontinued at the request of CCSD-FO; however, the specimen was re-assembled in order to perform a burst test.

- 13.4.1 Functional test data after 25, 50, 100 and 500 cycles are shown in tables 12-3 through 12-6.
- 13.4.2 Seat failure after 562 cycles is shown in figure 13-3.

During cycle 562, the valve would not seat regardless of the amount of torque applied. Disassembly inspection revealed a badly eroded KEL-F seat.

The valve is considered qualified for a cross country 6000 psig shut-off valve. The valve is suitable for mono directional flow (over the plug). It is not capable of fine metering because of the plug design. The valve's soft seat should be visually inspected for damage periodically and replaced as necessary.

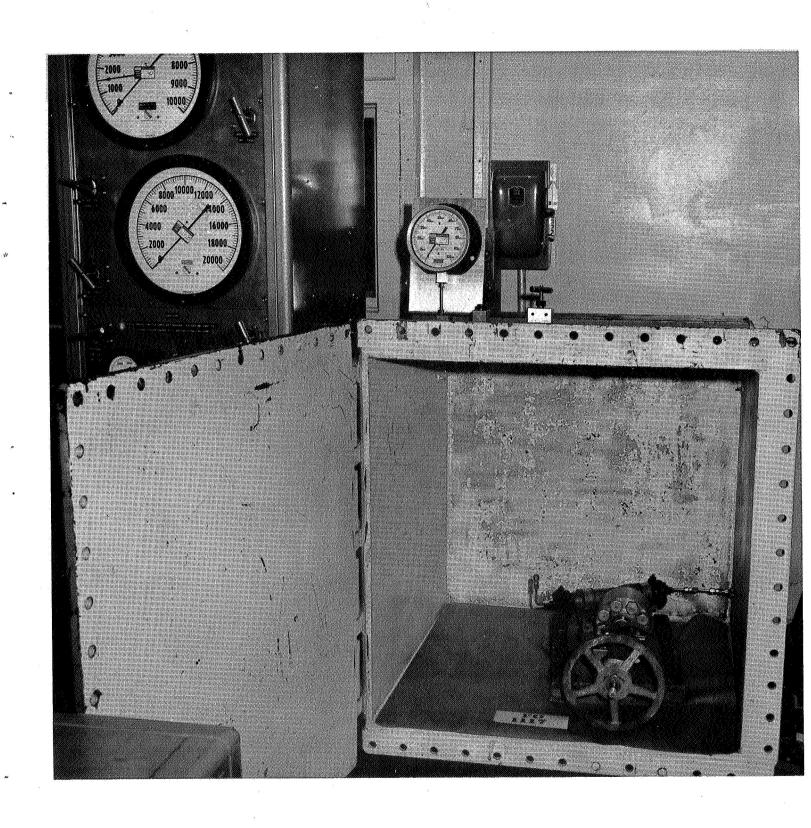
Figure 14-1. Burst Test Setup

14.2.7	Switch 17 was then closed. Solenoid valve 18 was opened and pump 19 started.
14.2.8	The pump continued to operate until a pressure of 22,000 psig was reached. At that level, a water leak was noticed under the door of the burst chamber. The pressure then decreased and all attempts to bring the pressure up failed.

14.2.9	Hand valves 9 and 11 were opened and the system was vented.
14.2.10	All data were recorded.
14.3	TEST RESULTS
	The specimen did not reach 24,000 psig during the burst test. Water leakage occurred at 22,500 psig through the bonnet gasket and escaped through the gland flange.
